**EXPERIMENTAL STUDY ON
THE INVESTIGATION OF
STRENGTHENING THE INSUFFICIENT
REINFORCED CONCRETE BEAM-COLUMN
JOINTS BY POST-TENSIONING**

Master of Science Thesis

Civil Engineering Program

August 2015

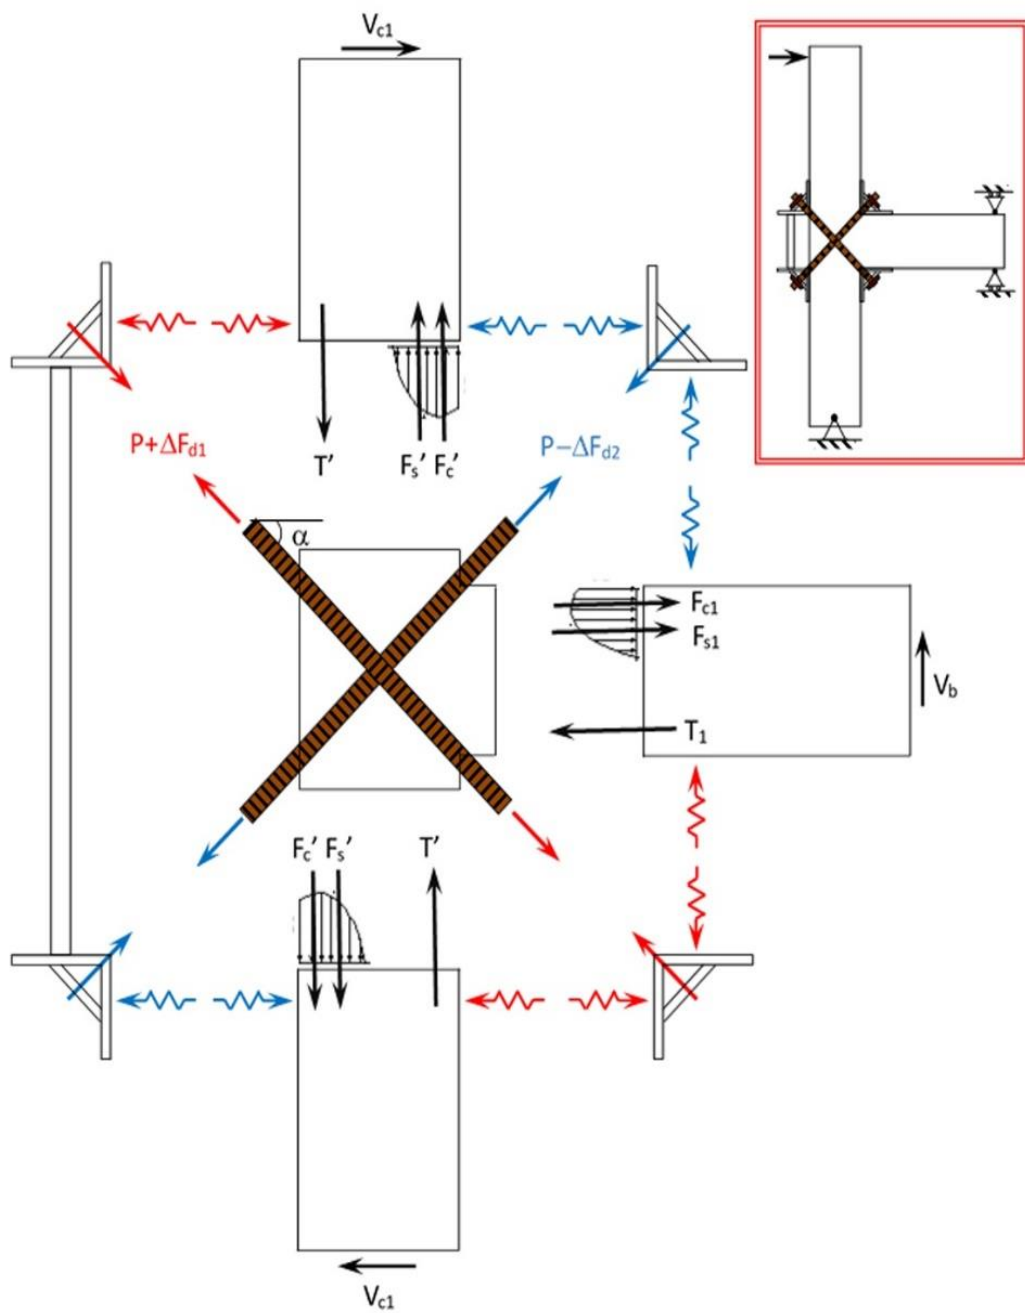
Figure 2.2. Load transfer mechanism in the retrofitted specimen

As the tested specimens represent the exterior beam-column joint, the load transfer mechanism is visually presented in the retrofitted joints via post-tension. The equation of equilibrium for the retrofitted specimens through the post-tension was also presented in this section.

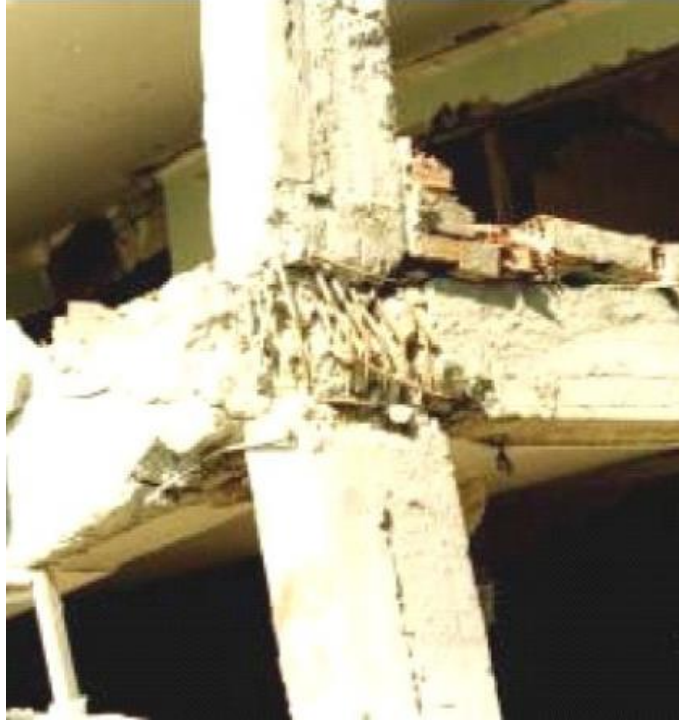
Figure 2.4. Erzincan-Turkey Earthquake (1992), Photo credit: Güney ÖZCEBE [8]

Non-seismically designed RC frames suffer from brittle type of failure at local level such as shear failure of beam-column joint. This can result in moderate to severe structural damage or even the total collapse of moment-resisting frame buildings. The reconnaissance reports for the recent earthquakes on the substandard RC joints show the damage level in the existing buildings [1,11,12]. Figure 2.4- Figure 2.8 visually present the severity of damages in the past earthquakes. Examples including joint failures are Erzincan-Turkey Earthquake (1992), Adapazarı-Turkey Earthquake (1999), L'Aquila-Italy Earthquake (2009), Simav-Turkey Earthquake (2011).

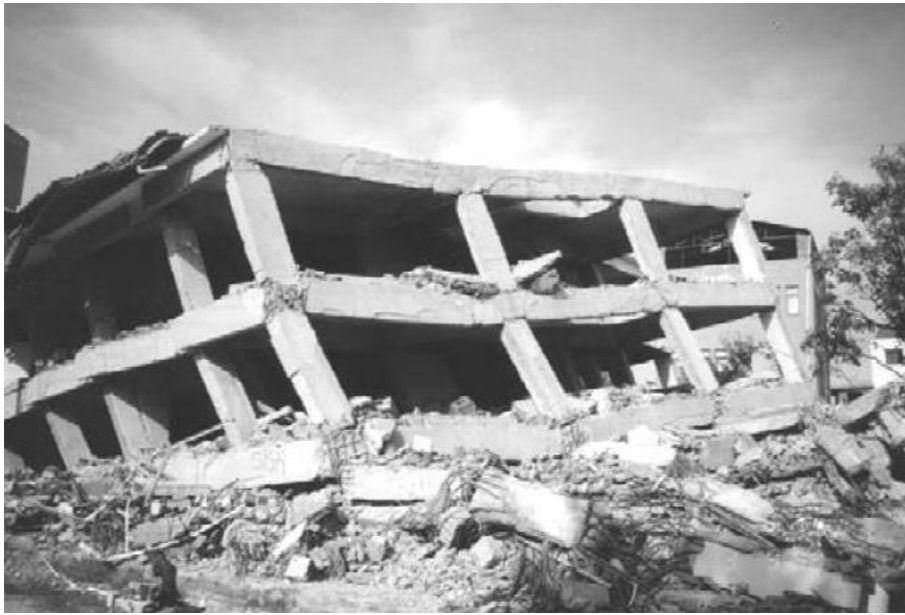
Figure 2.5. Collapsed building in Adapazarı-Turkey Earthquake (1999) [13]

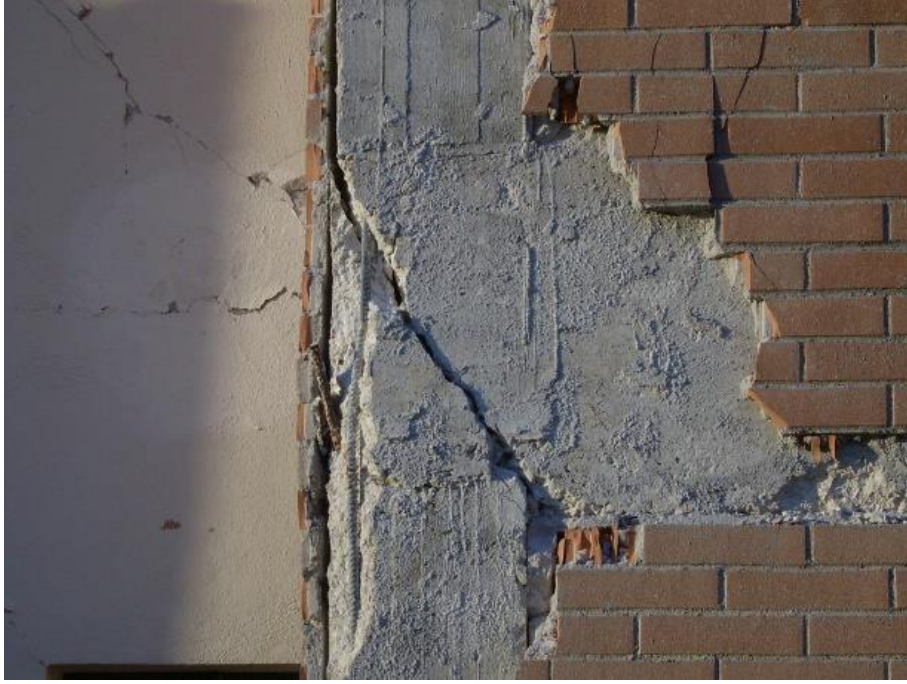
Figure 2.6. L'Aquila-Italy Earthquake (2009), Photo credit: Özgür AVŞAR [14]

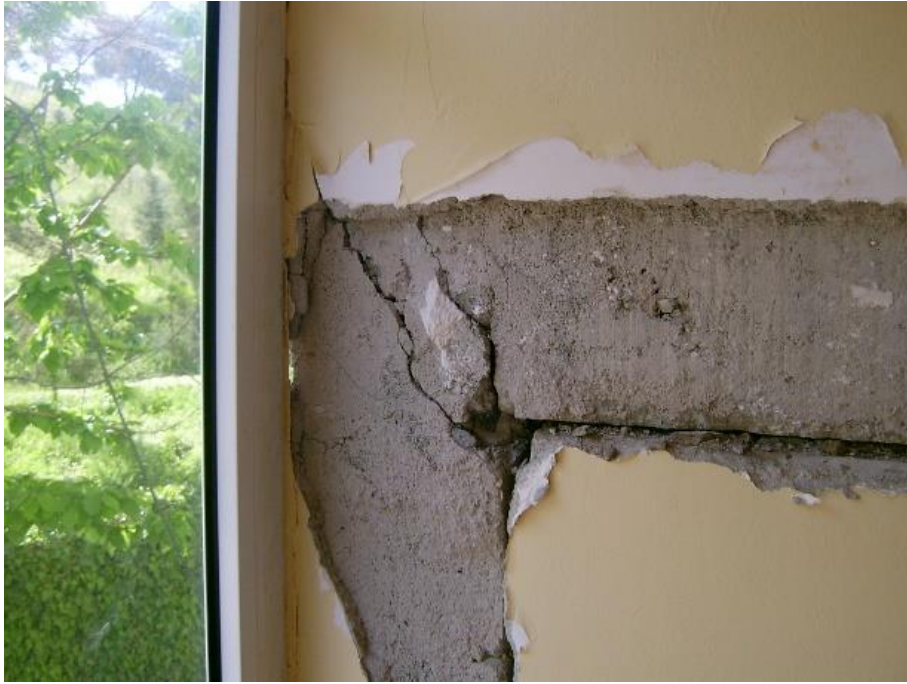
Figure 2.7. Simav-Turkey Earthquake (2011), Photo credit: Özgür AVŞAR [14]

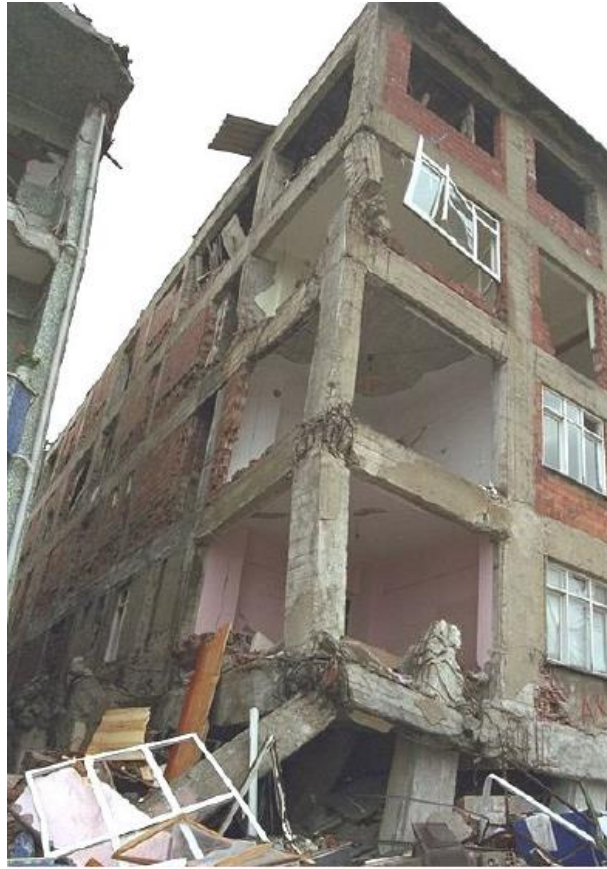
Figure 2.8. Adapazarı-Turkey Earthquake (1999), Photo credit: NISEE [15]

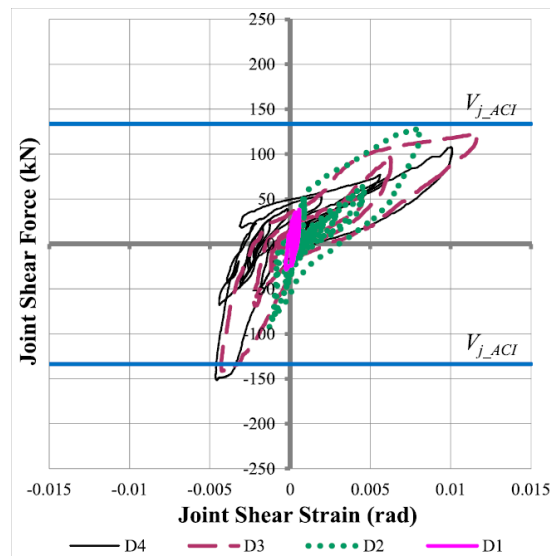
Figure 3.8. (a) Ground motion data (b) response of exterior joint [22]

Unal and Burak [22] present the response of one exterior and one interior joint of a 1:2 scale three storey frame. Pseudo-dynamic testing method was carried out the seismically designed frame to represent the earthquake excitations with different intensities (Figure 3.8a). Even though the design parameters of the joint comply with the TEC 2007 [4] and ACI 352-2002 [3], failure type was partially joint mechanism for the high intensity earthquake loading (Figure 3.8b). Nevertheless, the frame continued to carry the applied gravity load without significant lost in its lateral load-carrying capacity [22].

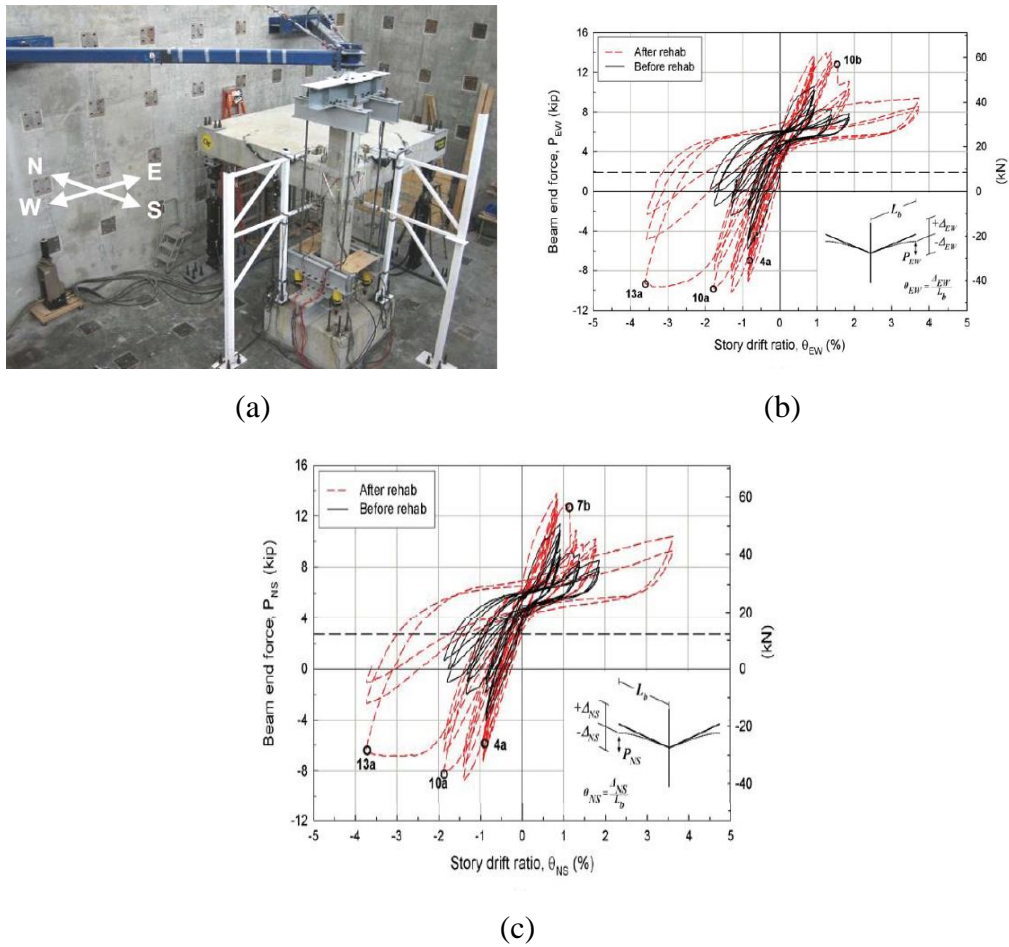
Figure 3.11. (a) Bidirectional loading (b) EW direction (c) NS direction [25]

Engindeniz et al. [25] present the response of a 1:1 scale RC joints constructed with transverse beam and slab (Figure 3.11a). The specimen were first tested under bidirectional quasi-static loading, then repaired and retested. Severe damage was observed in the joint region as the specimen was constructed according to the pre-1970s construction practices like absence of shear reinforcement in the joint. The pre-damaged specimen was first repaired by pressure-injection of a high-strength, high-modulus, low-viscosity epoxy that filled all cracks larger than 0.3 mm. Then, CFRPs were wrapped to the damaged members. The experiment result indicated that application of the CFRPs was efficient to achieve ductile beam failure. The specimens could sustain the lateral load capacity up to 3.7% drift ratio without any loss in the applied axial load (Figure 3.11 b and c).

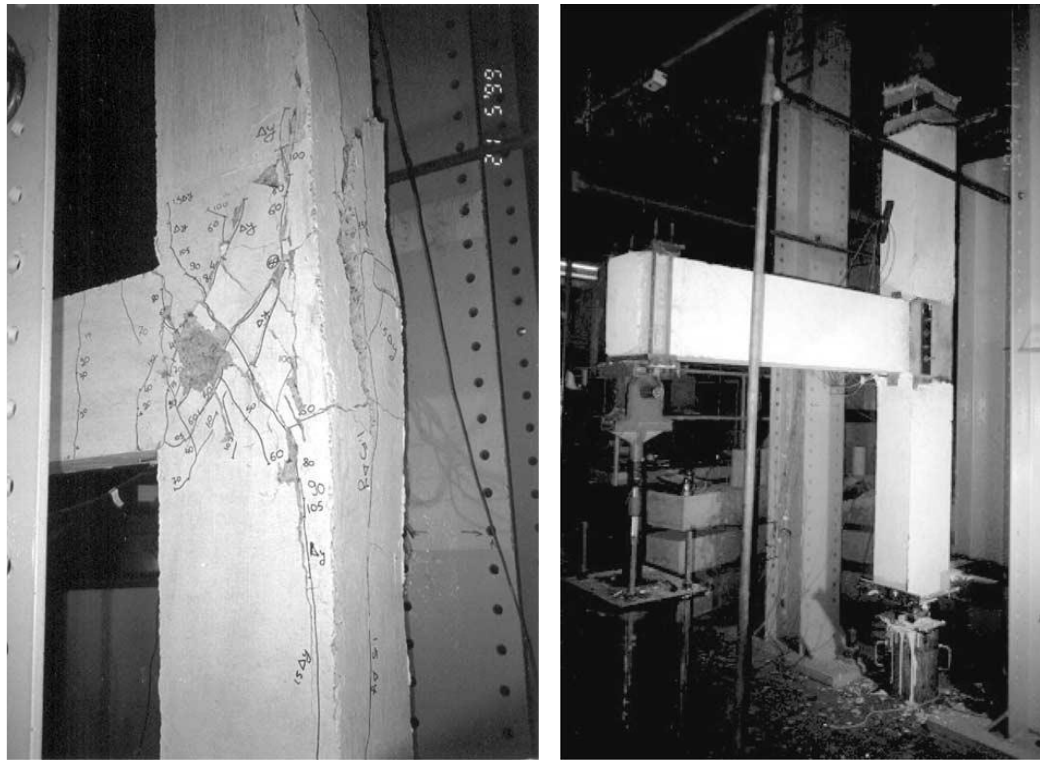
Figure 3.12. Specimen TR1 (a) before (b) after repair [26]

Ghobarah and Said [26] present the repair of the exterior beam-column joint specimens by means of glass fiber-reinforced polymer (GFRPs). Four joint specimens representing the existing pre-1970s buildings were tested. While two of the specimens repaired after testing, the remaining specimens retrofitted before any damage was done (Figure 3.12). Two different levels of axial load were applied (300 and 600 kN). Four different FRPs wrapping technique was used. The FRP sheets were applied in U pattern to the joints in the repaired specimens. The FRP was not extended to the upper and lower storey column in the first specimen. The case was opposite to the presented case of the first specimen. The joint shear mode could be either eliminated or delayed with the proposed repair technique. This, of course, meets the main objective of repair.

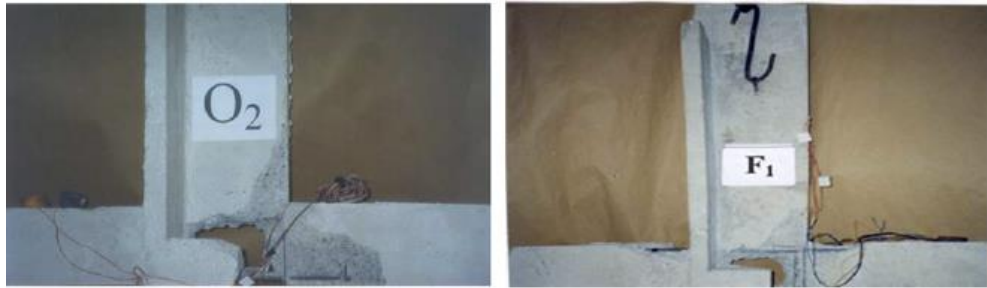
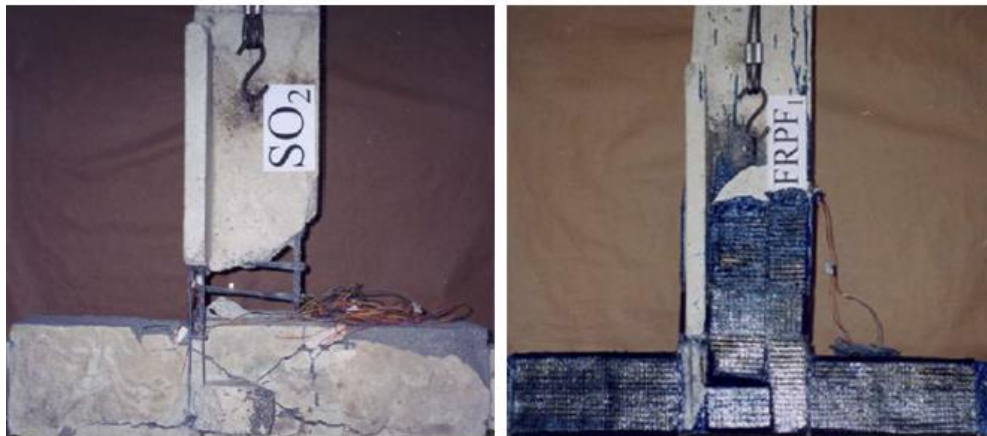
Reference Specimens

Repaired Specimens

Figure 3.13. Damaged photos of reference and repaired specimen [27]

Tsonos [27] reports the repair and retrofit of four exterior beam-column joints built with transverse beam and slab. Four non-seismically designed joint specimens were tested under cyclic loading. All specimens were constructed with several structural deficiencies such as absence of shear reinforcement in the joint, inadequate column shear reinforcement, non-optimal flexural strength ratio and joint shear strength. One of the specimens (F_1) was repaired by epoxy jacketing/CFRPs, (Figure 3.13). On the other hand, another conventional method, which is RC jacketing, was applied in the remaining specimen, O_2 (Figure 3.13). A brittle joint shear failure was observed in the built up specimens. After repairing the specimens, the brittle failure was transformed to the ductile behavior with flexural beam hinging.

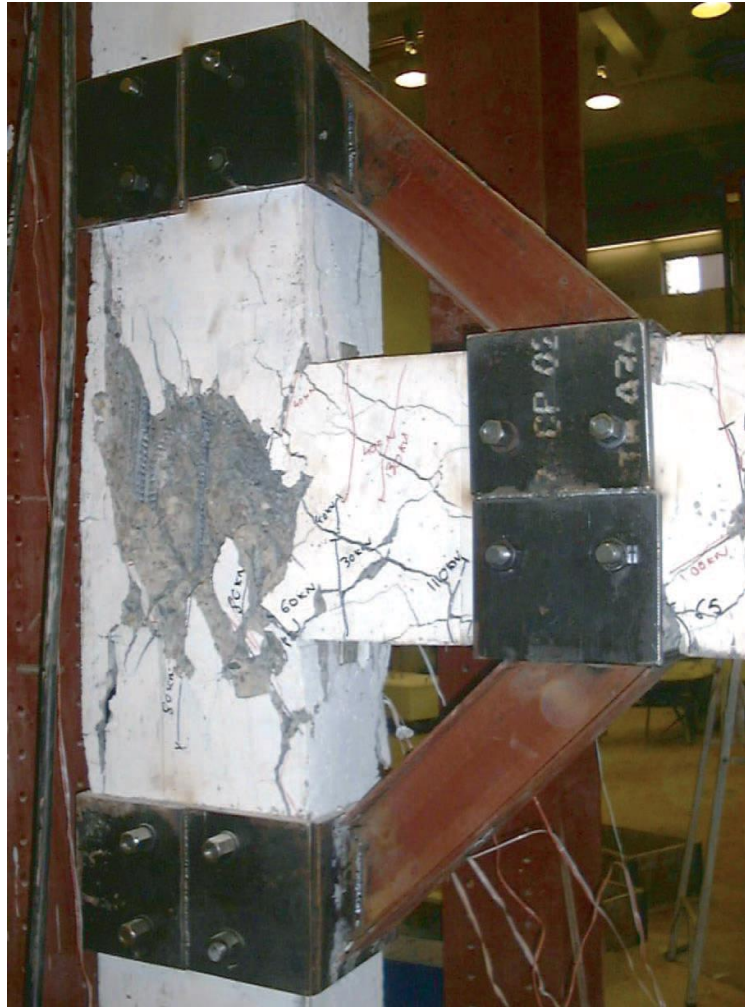
Figure 3.15. Crack patterns in retrofitted specimen [29]

Said and Nehdi [29] present the retrofit of non-seismically designed RC exterior beam-column joints via local steel bracing. While one specimen was constructed with transverse reinforcement the joint, there was no shear reinforcement in both control and retrofitted specimen. The loading history involves two sections, which are load controlled, and displacement controlled part. A ductile behavior with beam yielding was observed in the specimen complying with code requirement. However, control specimen displayed a brittle behavior with a severe damage in the joint. The steel braced enhanced the peak load 2.6 and 1.7 times in positive and negative directions, respectively. This, of course, delayed the brittle joint shear failure and bond slip failure. Nevertheless, the cracks were concentrated mostly in the joint core (Figure 3.15).

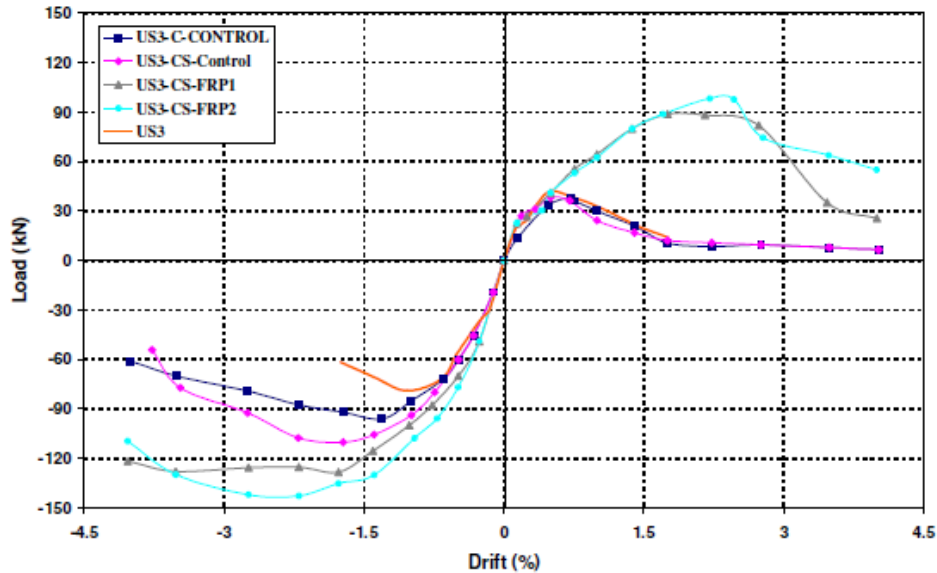
Figure 3.16. Backbone curves of hysteresis loops [30]

Topcu [30] deals with the strengthening of external beam-column joints via CFRPs. The effect of transverse slab was also investigated in this study. All specimens were constructed with plain round bars. The anchorage detail was designed such that the beam bottom bars were embedded shorter than required length. Therefore, the bond slip failure preceded the overall response in the reference specimen with transverse slab. Even though the peak load was enhanced, the bond slip characteristic was not affected by slab. The bond slip failure was transformed to other failure modes such as joint shear failure and ductile beam hinging by retrofitting with CFRPs. A ductile beam failure was observed in one of the retrofitted specimens. Even though the joint shear failure was fully prevented in this specimen, the bond slip failure was only delayed to the subsequent drift ratios

(Figure 3.16). This study yet again proved that the bond slip failure could not be easily prevented by CFRPs wrapped in different orientations.

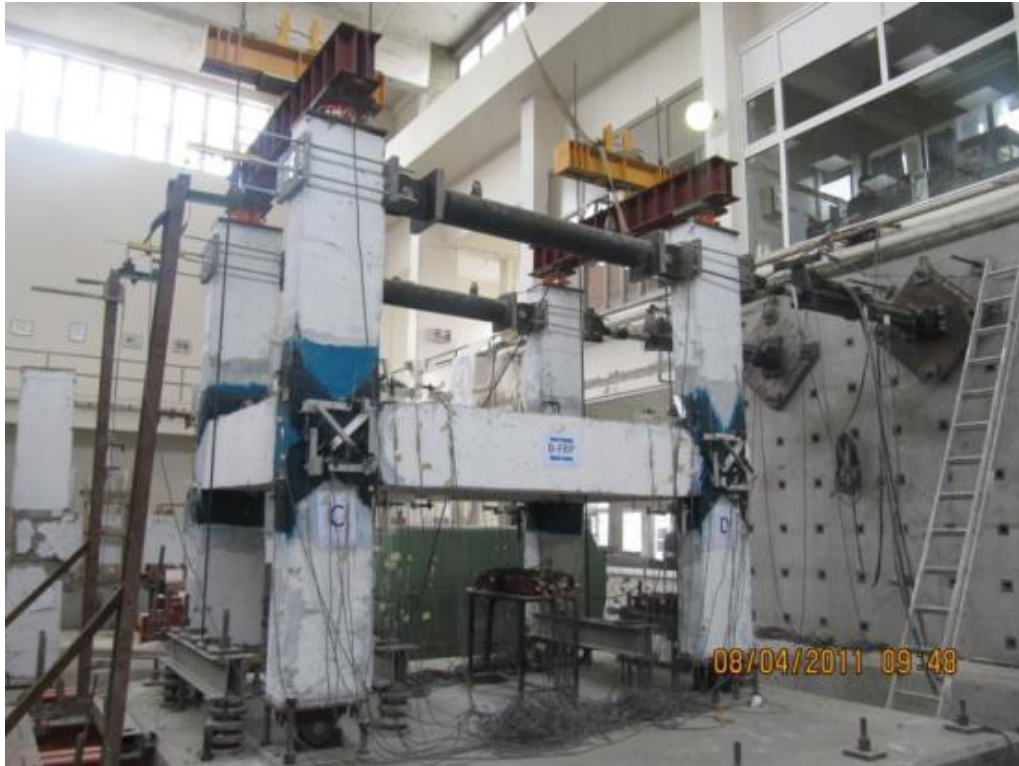
Figure 3.17. CFRPs retrofitted specimen [31]

Coskun et al. [31] tested two full-scale three-dimensional reinforced concrete frames under reversed cyclic quasi-static load up to 8% drift ratio. The loading pattern was obtained from the time history analysis of an actual structure hit by Düzce Earthquake. The specimens represented the most common characteristics of Turkish building stocks, which has low strength concrete and poor reinforcement detail such as absence of shear reinforcement in the joint and use of plain round bar. One of the tested specimen was retrofitted by CFRPs which were applied in X pattern to the joint (Figure 3.17). The combination of bond slip and joint shear failure preceded the overall response in the reference specimen. On the other hand, the retrofitted specimen could sustain the 95% of lateral load capacity at 8% drift ratio, which indicates the efficiency of retrofit technique. In addition, outcome of this study highlighted the applicability of CFRPs wrapping technique in X pattern to the joint.

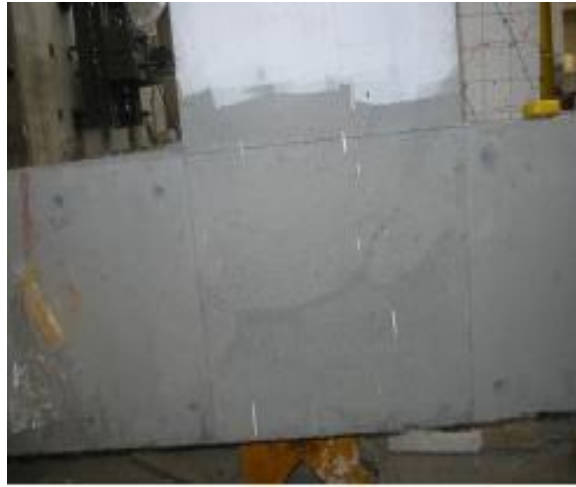
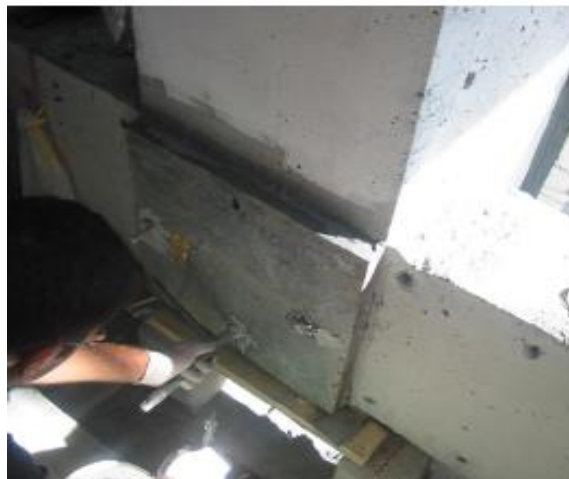
Bedirhanoglu et al. [34] investigate the response of the deficient reinforced concrete exterior joints built with low strength concrete and plain round bars before and after retrofit through high-performance fiber-reinforced cementitious composite (HPFRCC). The epoxy resin was first applied to the surface and then HPFRCC panels were anchored to the joint by steel rods (Figure 3.19a and b). There were four-tested specimens -two reference and two retrofitted- in this study. The effect of welding of beam bottom and top hooks to each other was also investigated in both control and retrofitted specimens. The bond slip failure preceded the overall response in the specimens constructed with bent up anchorage detail. On the other hand, the combination of bond slip and joint shear failure was observed in the specimen whose beam top and bottom hooks were welded. The shear deformations in the joint core were limited by HPFRCC panels and plastic hinges took a place in

Figure 3.19. (a) Application of epoxy resin (b) anchoring HPFRCC panel [34]

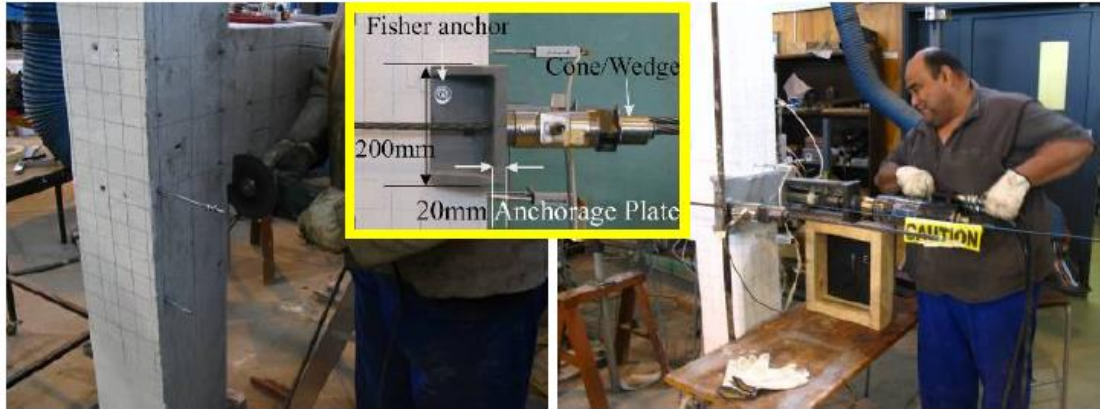
Kam and Pampanin [36] proposed a member retrofit technique called as selective weakening. In this method, the joint and the beam were retrofitted by post-tension wires. However, the beam flexure capacity can be increased by additional axial force provided by post-tension. Therefore, other members can fail before plastic hinge takes a place in the beam for certain cases. Hence, beam flexure capacity is weakened by severing beam longitudinal reinforcements (Figure 3.21). If the column capacity is greater than the beam and joint capacity, post-tension force is enough to prevent damage in the joint. There were four-tested specimens in this study. A joint shear failure was observed in the benchmark specimen. In the specimen retrofitted with only post-tension, the failure mode was beam and column

Figure 3.21. Beam weakening and application of post-tension [36]

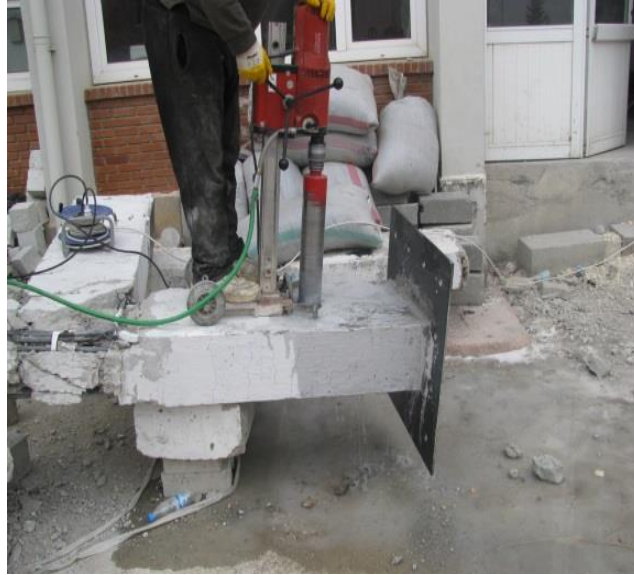
Curing of concrete was another factor affecting the strength so a special interest was also given on it. Curing of concrete is achieved by use of wet burlaps covering. After testing the specimens, the core samples were taken from the non-damaged part of the members (Figure 4.4). The strength of concrete core samples was presented in Table 4.4.

Figure 4.4. Core sampling

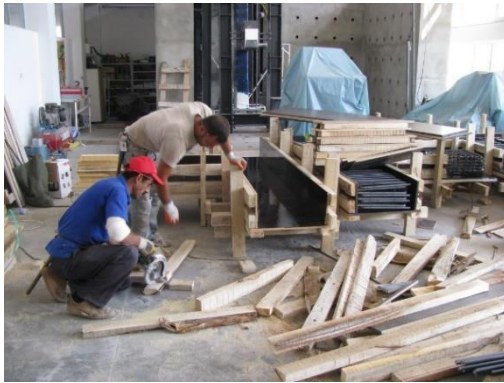
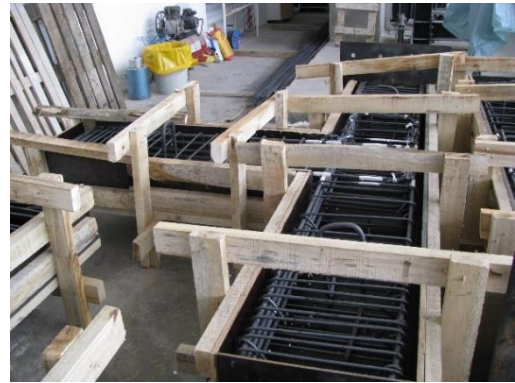
Figure 4.5. (a) Assembling of the form (b) final shape of the form

The T-shape RC beam-column joint specimens were constructed at Structural Mechanics Laboratory, Department of Civil Engineering, Anadolu University. The forms of the specimens were prepared first, followed by the tying up of stirrups to the bent bars which were formed the required shape (Figure 4.5 and Figure 4.6). Then, the manufactured bars were installed to the form. Finally, the concrete was poured straight into the forms, which were manufactured in the horizontal position (Figure 4.7). Curing of concrete is achieved by use of wet burlaps covering. It should be noted that the specimens of each group were manufactured concurrently to eliminate the effect of concrete strength on the response.

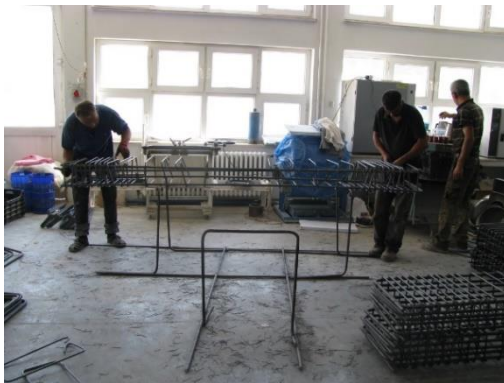
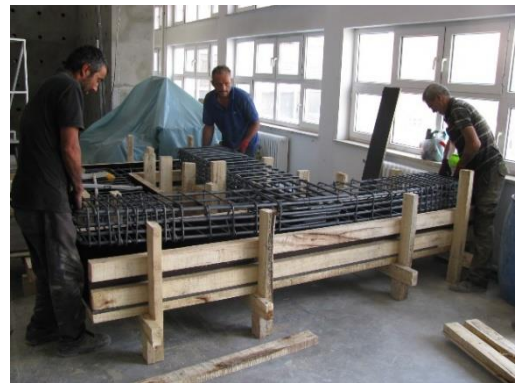
Figure 4.6. (a) Handling of bars (b) installation of the bars

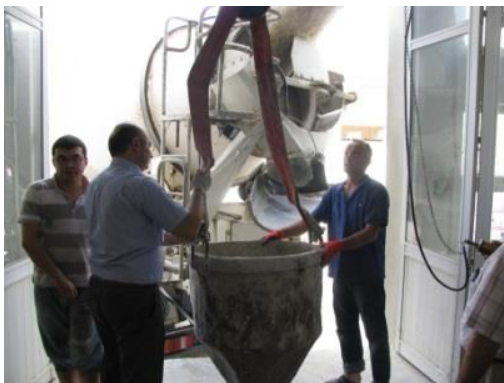
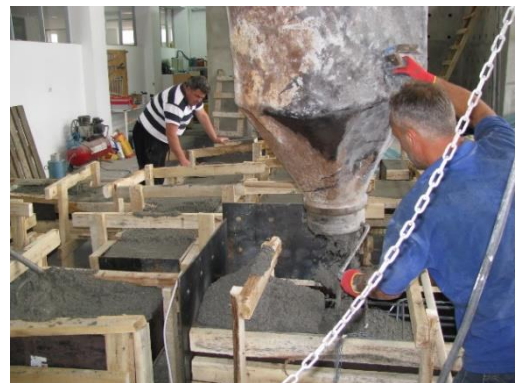
Figure 4.7. (a) Ready mix concrete (b) pouring concrete

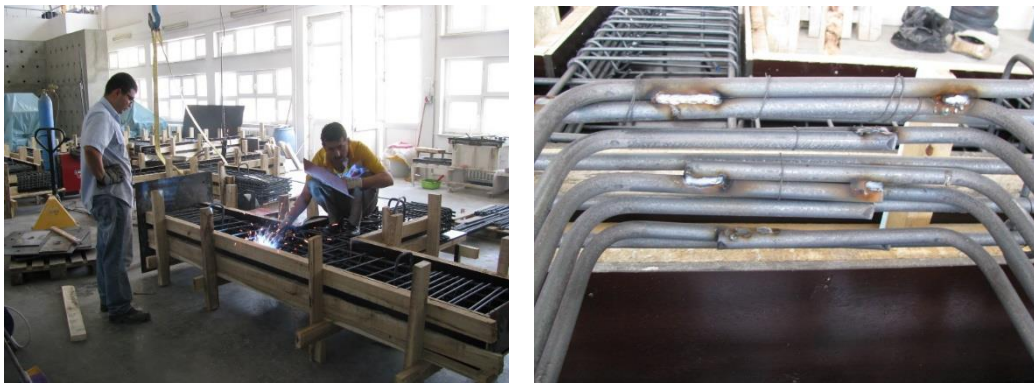
Bond slip failure can be partially prevented even in the existing buildings by removing the concrete cover at joint back, welding the the hooks of beam bottom and top reinforcement bars to each other and repairing with mortar [54]. The slippage failure modes therefore can be switched to the other failure modes. Proposed retrofit methods -use of CFRPs in X pattern and externally applied post-tension rods- are not effective in reducing the bar slip deformations of the plain bars. For this reason, occurrence of the slippage problem is intended to be minimized through welding of beam bottom and top hooks to each other before pouring of concrete (Figure 4.8).

Figure 4.8. Welding of beam hooks

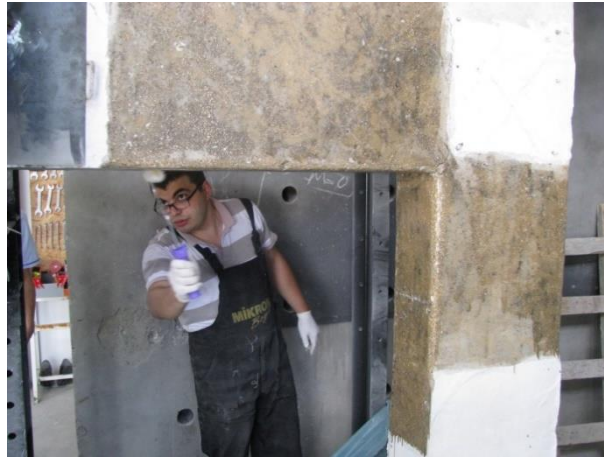
sections. Then, a thin layer of undercoat (MBT-MBrace® Primer) was applied on the corresponding RC component (Figure 4.9).

Figure 4.9. Application of MBT-MBrace® Primer

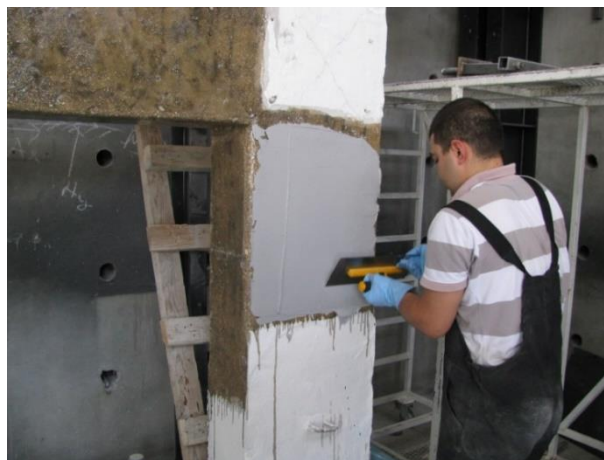
Once the undercoat dries, a thin layer of epoxy based, repair and anchorage mortar (Concessive® 1406) was applied to obtain smooth surface (Figure 4.10).

Figure 4.10. Application of Concessive® 1406

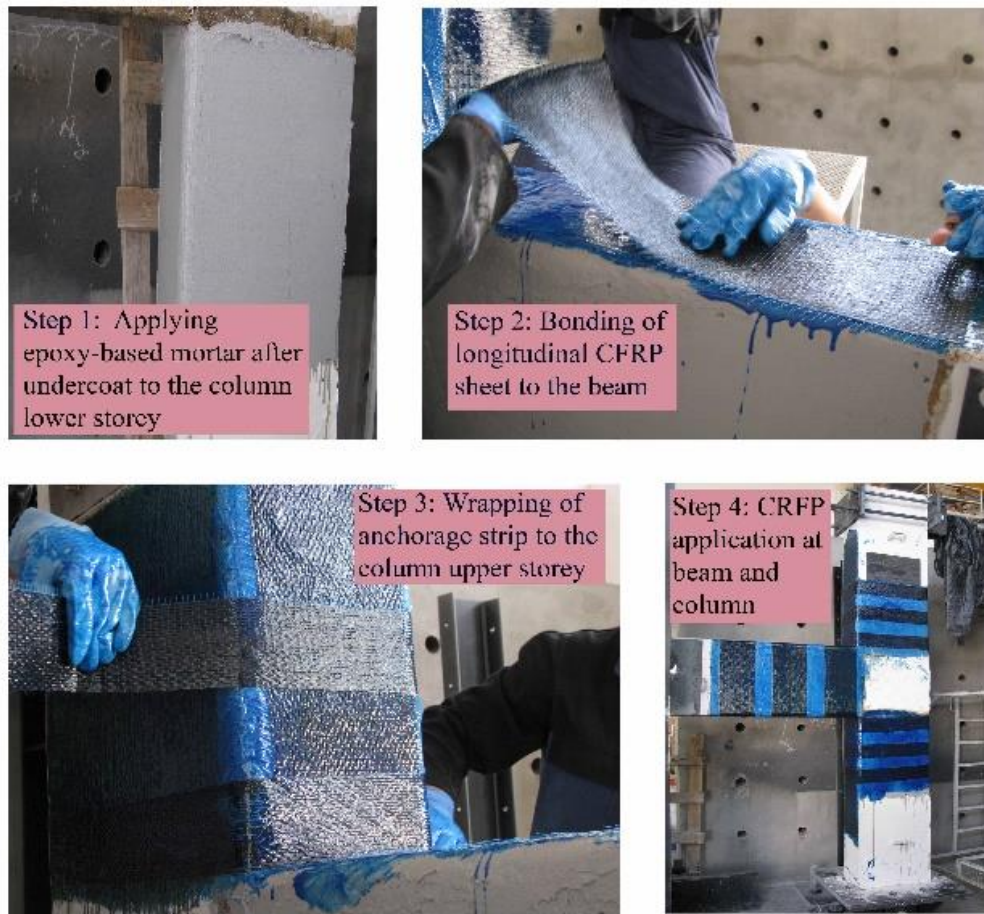
The repair process of the specimen EJ-1-R is also presented in Figure 4.13.

Figure 4.13. The repair process of EJ-1-R as shown in Figure 4.12

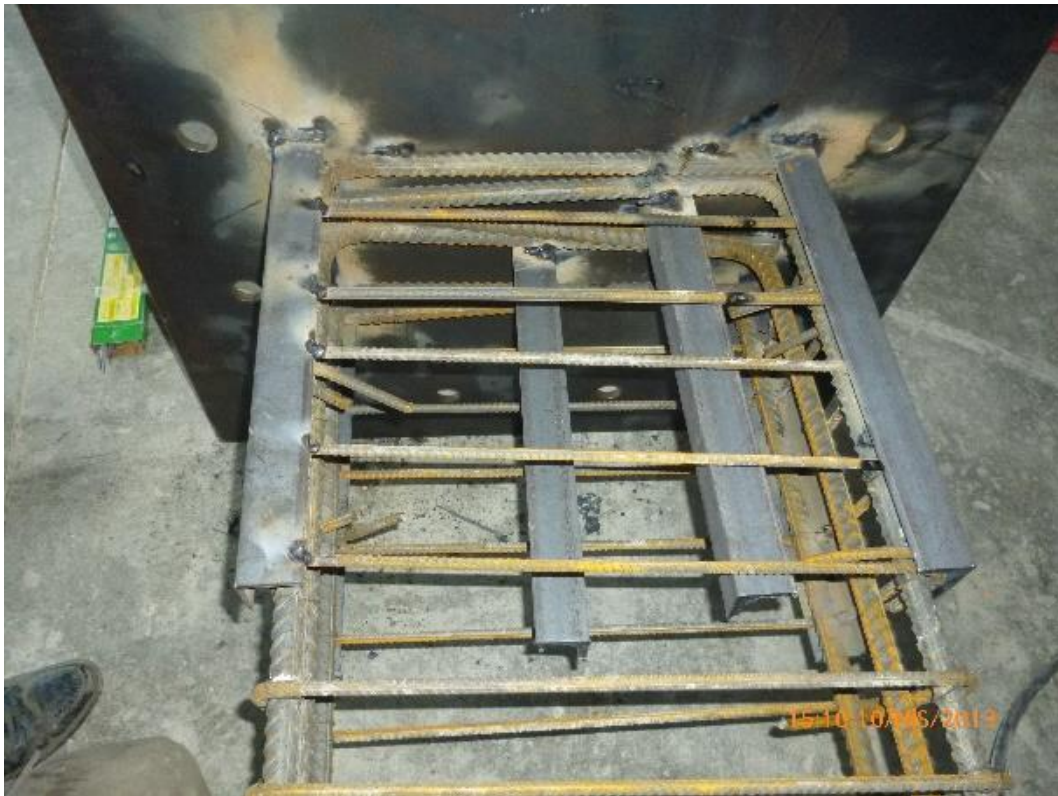
Six equal length angles with dimensions of 40x4x400 mm were welded to firstly 800x800x10 mm plate, which is called as column bottom plate, then to column longitudinal bars and its hooks for mounting the pin support to column (Figure 4.18). After that, the column bottom plate was fixed with eight 30 mm bolts to the top plate of pin support.

Figure 4.18. Detail of column bottom plate

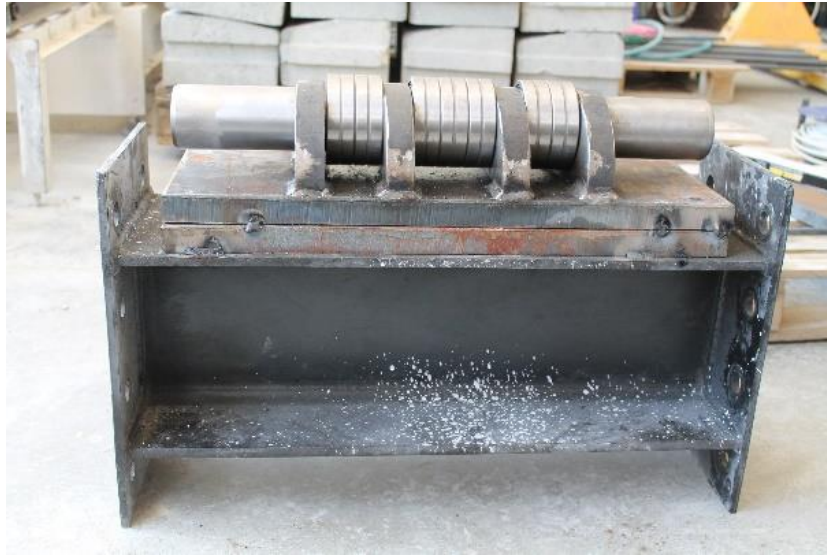
The beam was positioned horizontally and supported by roller support at the end. The roller support was provided by seven cylindrical rolling bearing units (Figure 4.19). Two plates with dimensions of 250x500x30 mm were mounted between the bearing units and the beam top-bottom surface at the beam end to eliminate the large bearing stress concentrations and hence to prevent concrete crushing in specified area.

Figure 4.19. Roller support detail

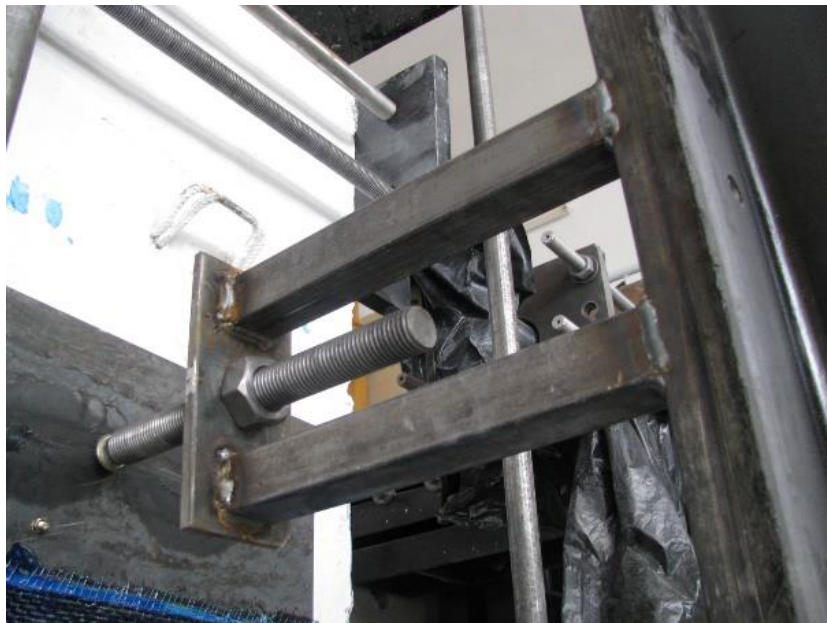
The specimens were laterally supported by bearing units from beam-end and top of column to prevent out of plane movement (Figure 4.20).

Figure 4.20. Prevention of out of plane movement

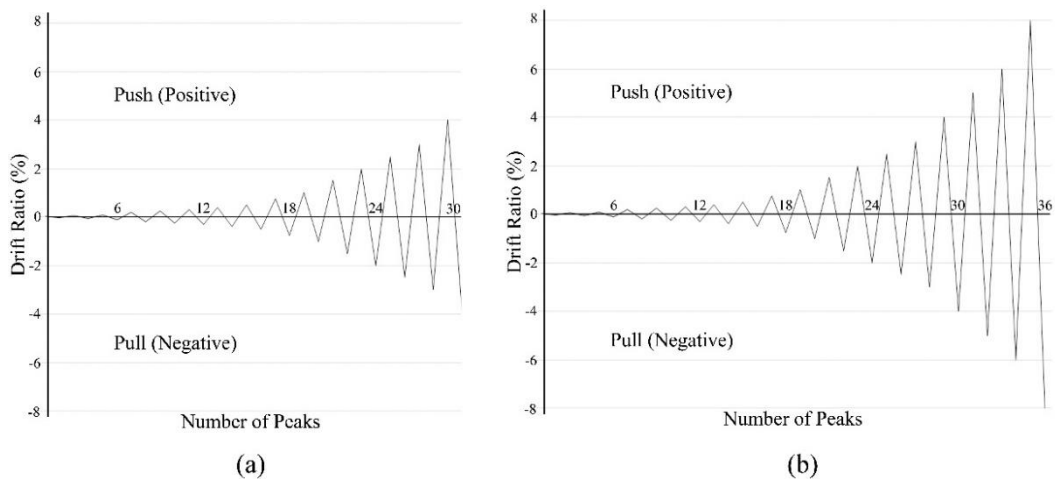
Figure 4.24. Displacement history (a) test series 1 (b) test series 2, 3 and 4

Quasi-static cyclic lateral displacement was applied from top of column under the combined action of the constant column axial load so that the actual behavior of beam-column assembly can be investigated in the laboratory. Lateral displacements were carried out until the expected drift ratios. It should be emphasized that notified drift ratios are the ratio of measured lateral displacement to the distance between the point of application of lateral displacement and bottom of lower story column.

There were two different test sequences in this study. While applied drift ratio was up to 4% in the first test series, drift ratio of 8% was reached for rest of the test series. This inconsistency was due to the inadequate capacity of the test facility. The capacity of the hydraulic jack was limited up to displacement corresponding the 4% drift ratio in the experiment of test series 1 (Figure 4.24a). Then, a new hydraulic cylinder, which is capable to apply 8% drift ratio, was used in the following experiments (Figure 4.24b). This study would have been more interesting if drift ratio of 8% had been applied in the test series 1.

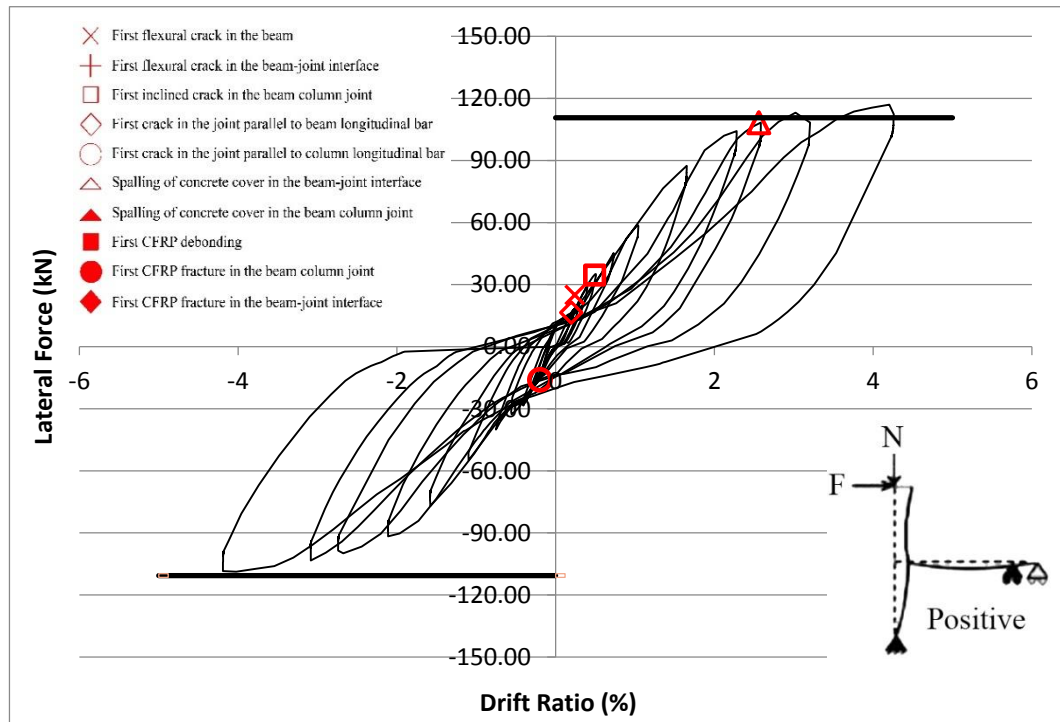
Figure 5.1. Hysteresis curve of the specimen EJ-1

The computed plastic flexural capacity of the beam, which corresponds to the lateral force capacity of the beam-column assembly, is 110 kN and the beam member reached that value with the global yielding of the assembly (Figure 5.1). The first flexural crack at beam was observed at 0.25% drift ratio, which corresponds to 17.5% of the maximum load before yielding the beam longitudinal bars.

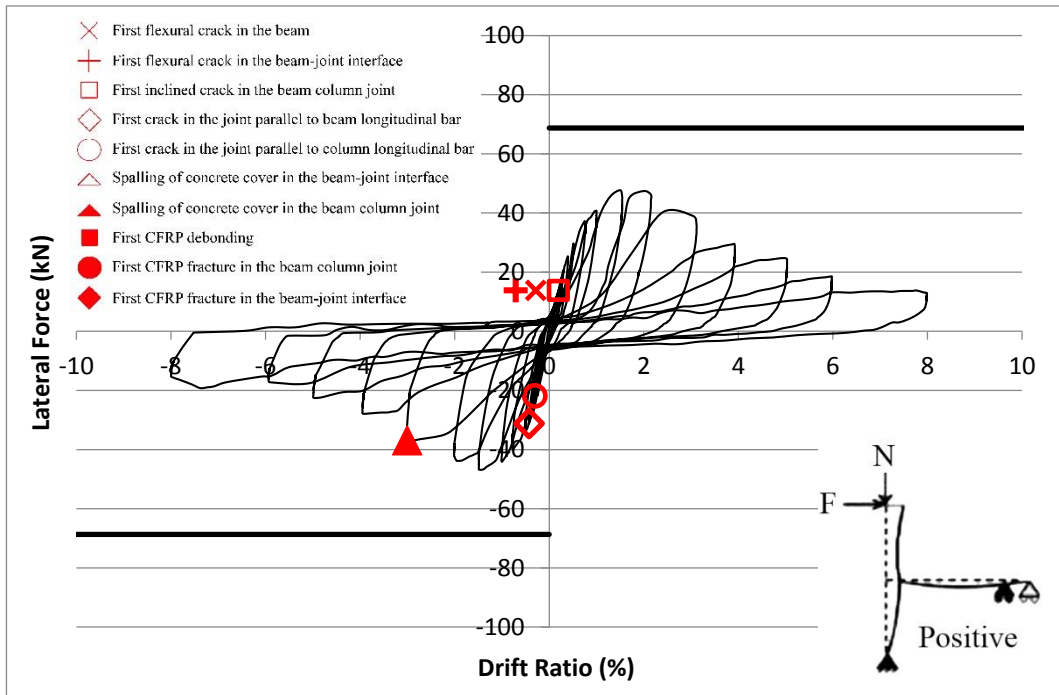
Figure 5.5. Hysteresis curve of the specimen EJ-2

The lateral load capacity of the test specimen is calculated as 68.9 kN for the initiation of plastic hinge at the beam end. However, as shown in Figure 5.5, the experimentally obtained ultimate lateral load is less than 68.9 kN, which indicates that the joint panel reaches to its shear capacity before the beam attains its flexural capacity.

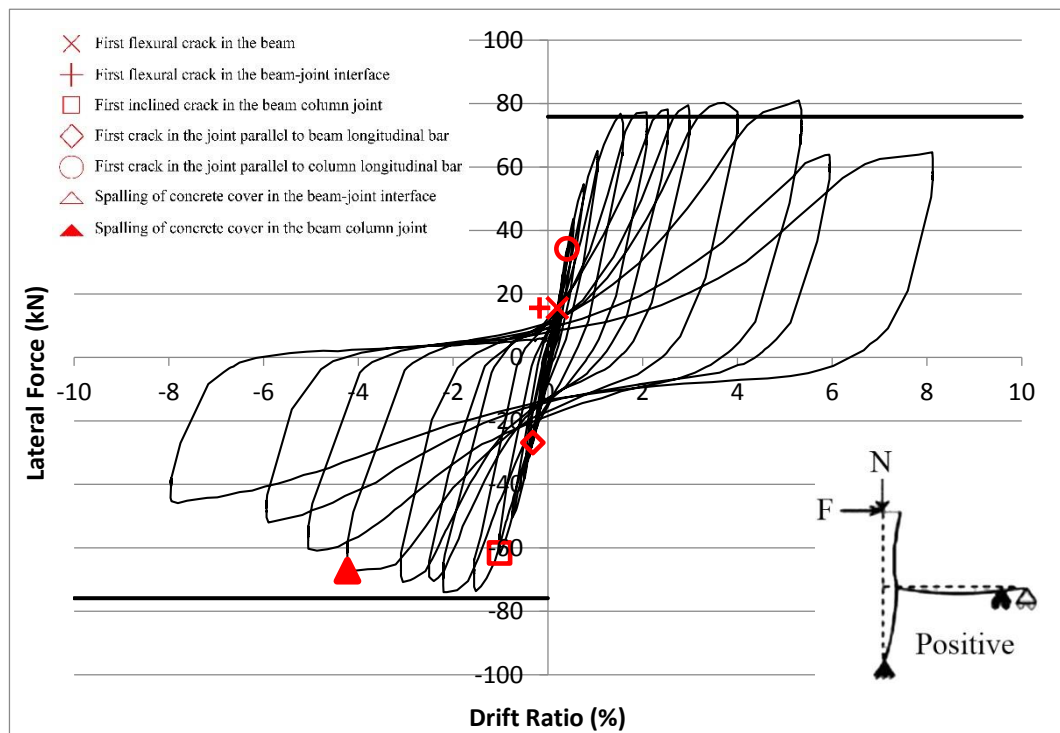
Figure 5.17. Hysteresis curve of the specimen EJB-P-3

The beam reached that value with the global yielding of the assembly (Figure 5.17). The first flexural crack in the beam occurred at 0.20% drift ratio that corresponds to 18.7% of maximum lateral load. Most of the propagated cracks in the beam occurred in the plastic hinge zone and did not extend the rest of the beam (Figure 5.18a and c). Formation of cracks stabilized in the beams and diagonal

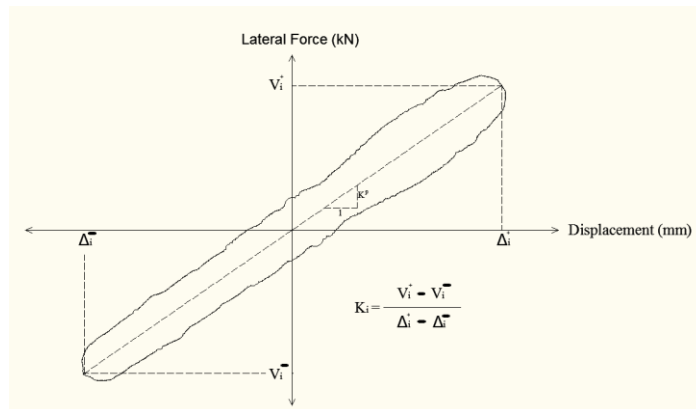
Figure 5.25. Peak-to-peak stiffness

The peak-to-peak stiffness, K^P , is the slope of the line that joins the ultimate load points in positive and negative direction of hysteresis loop at each loading cycle (Figure 5.25) [57]. The peak-to-peak stiffness at each loading cycle decreased when the applied lateral load devolved into inelastic range along with the increased level of damage. To make better comparison, the peak-to-peak stiffness was normalized with respect to the reference specimen.
