**EXPERIMENTAL STUDY ON
THE INVESTIGATION OF
STRENGTHENING THE INSUFFICIENT
REINFORCED CONCRETE BEAM-COLUMN
JOINTS BY POST-TENSIONING**

Master of Science Thesis

Civil Engineering Program

August 2015

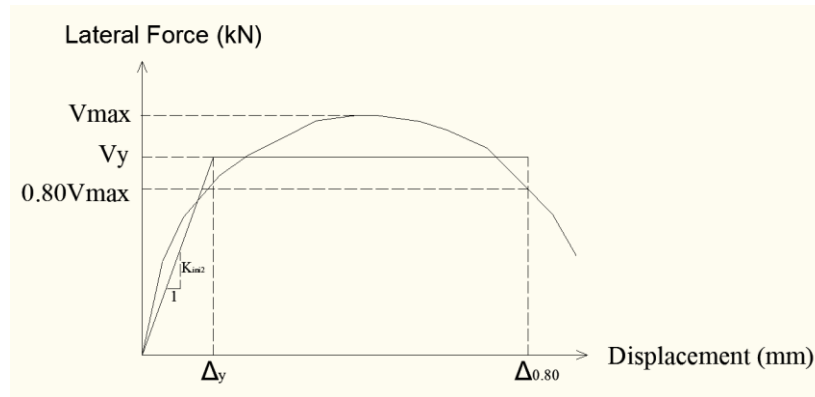
Figure 5.30. Bi-linear curve of the envelope curve

Ductility of the test specimens can be calculated by dividing the ultimate horizontal displacement, $\Delta_{0.80}$, which corresponds to the displacement when maximum lateral load reduces 20% to the yield displacement Δ_y (Figure 5.30) [57].

In order to determine the yield displacement, an equivalent elasto-plastic force-displacement relation was obtained to represent the nonlinear backbone curve such that the area under both curves in other words energy absorption capacities are the same [58]. An iterative process was implemented to achieve the equal area concept.
